An Analysis of McDonnell Douglas's Ethical Responsibility in the Crash of Turkish Airlines Flight 981

Executive Summary

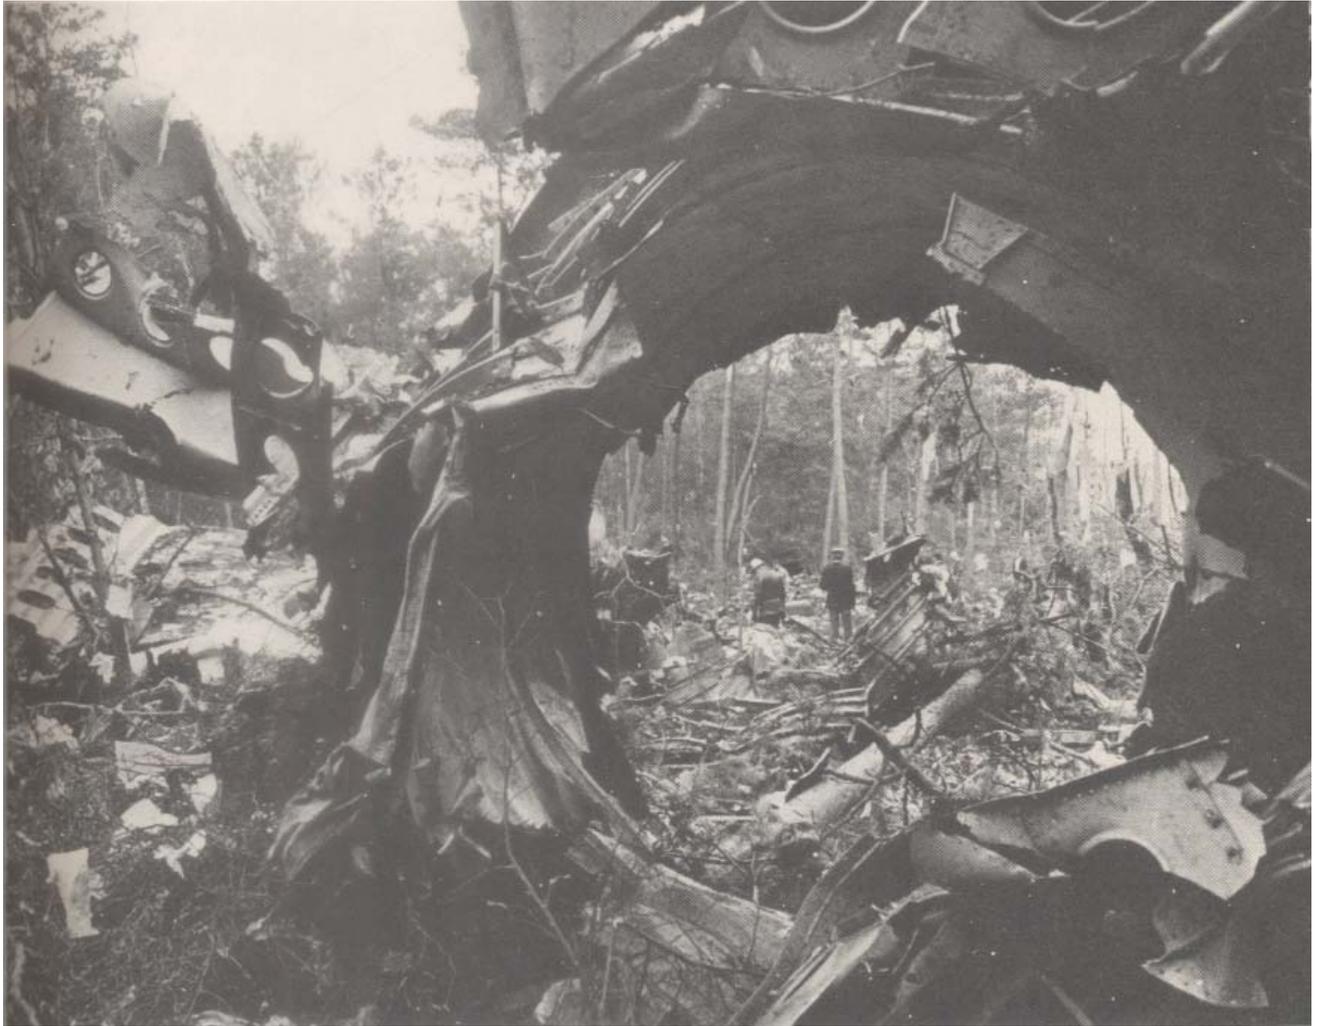
Figure 2: The wreckage of Flight 981 in the Ermenonville forest, March 3, 1974 (Eddy et al., 1976).

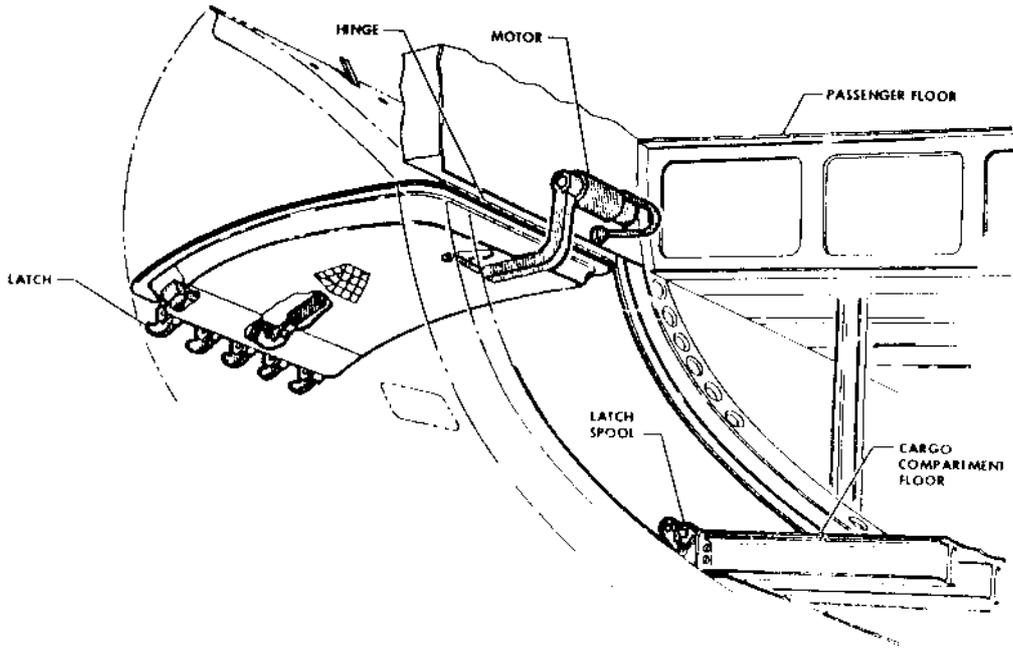
Passenger doors on every airplane are 'plug type' (inward-opening), and so while in-flight, the cabin pressure aids in keeping the door sealed shut. However, a cargo door is large and cannot be made this way due to interior space issues. Thus it is common practice for the doors to be designed to hinge outward with a series of latches, or hooks, which rotate around a latch spool and use the interior pressure to hold the door tightly in place (see Fig. 3). This rotation is driven by an actuator which moves the latches into place through a linkage. The rotation is completed when the linkage passes 'over center', thereby causing the pressure forces conducted through the latches to keep the door shut. As an additional measure, locking pins then move into place which prevent backward movement of the linkage (see Fig. 4-a). Finally, a small vent door is installed as a visual indicator of proper closure such that it only closes once the lock pins are in place, allowing the cargo hold to pressurize (see Fig. 5-a). This door is closed by turning the external handle (Fielder, 1992, pp. 72-73).

Figure 3: The rear cargo door on the DC-10. (Fielder et al., 1992).

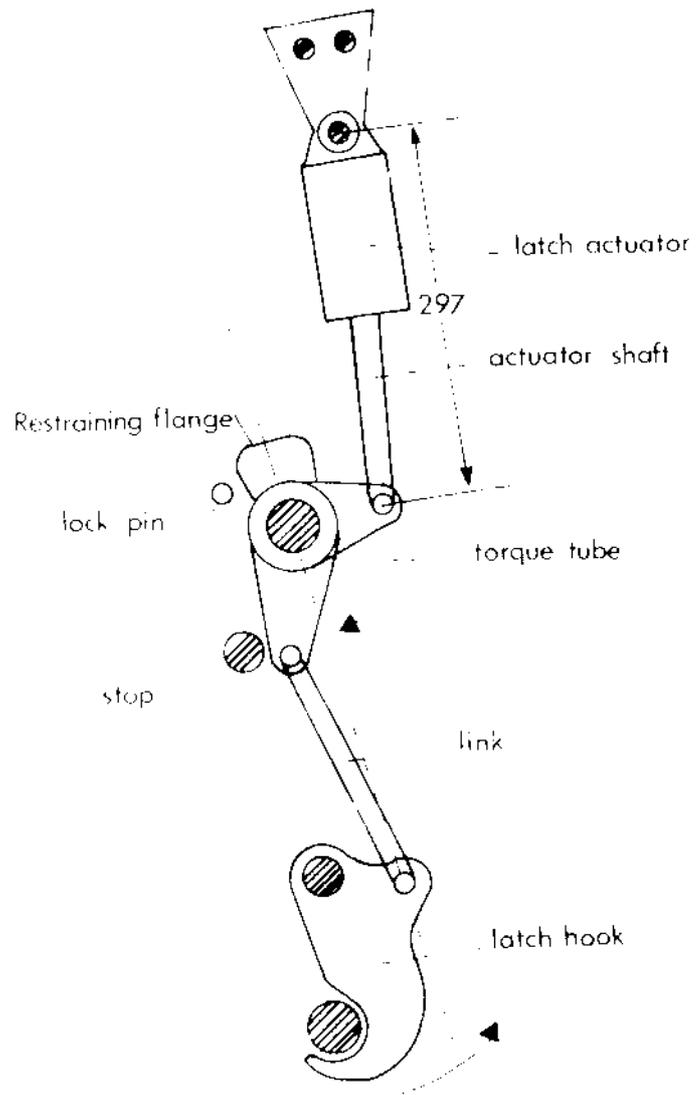
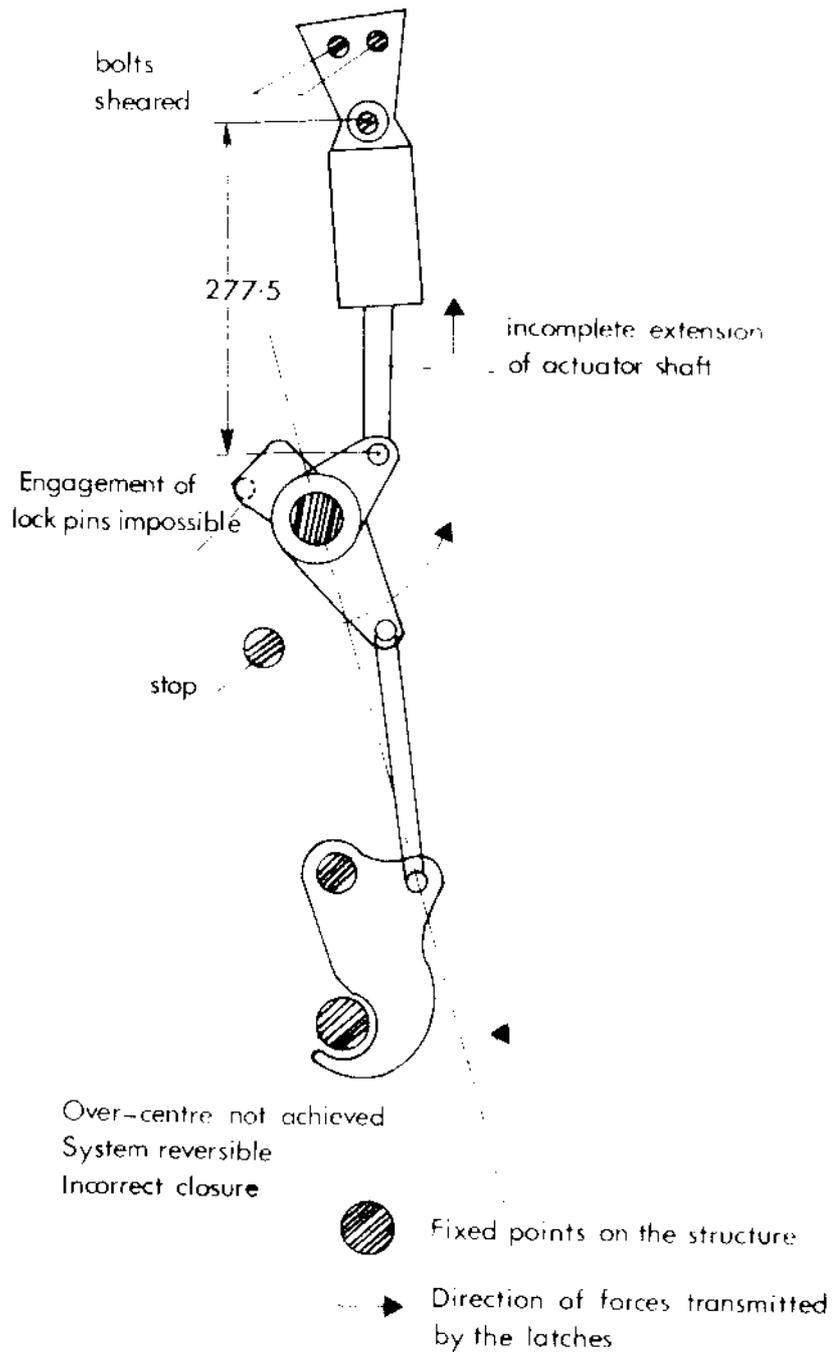
Over-centre achieved
 System irreversible
 Correct closure

Figure 4: The latch linkage in (a) the correct, 'over center' position, and (b) the false closure position (Eddy et al., 1976).

readily possible to bend the linkage torque bar such that the linkage would not reach the 'over center' position (see Figs. 4-b and 6), and when the locking pins subsequently jammed, the operator was still able to close the vent door by forcing the cargo door handle into place (Fielder, 1992, pp. 77-78).

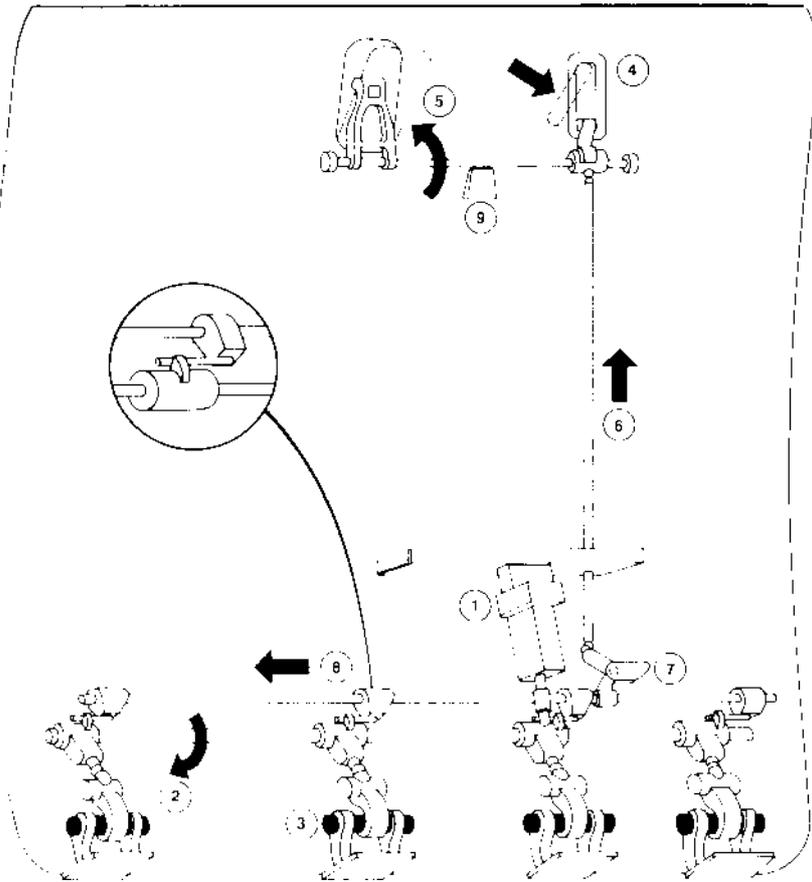
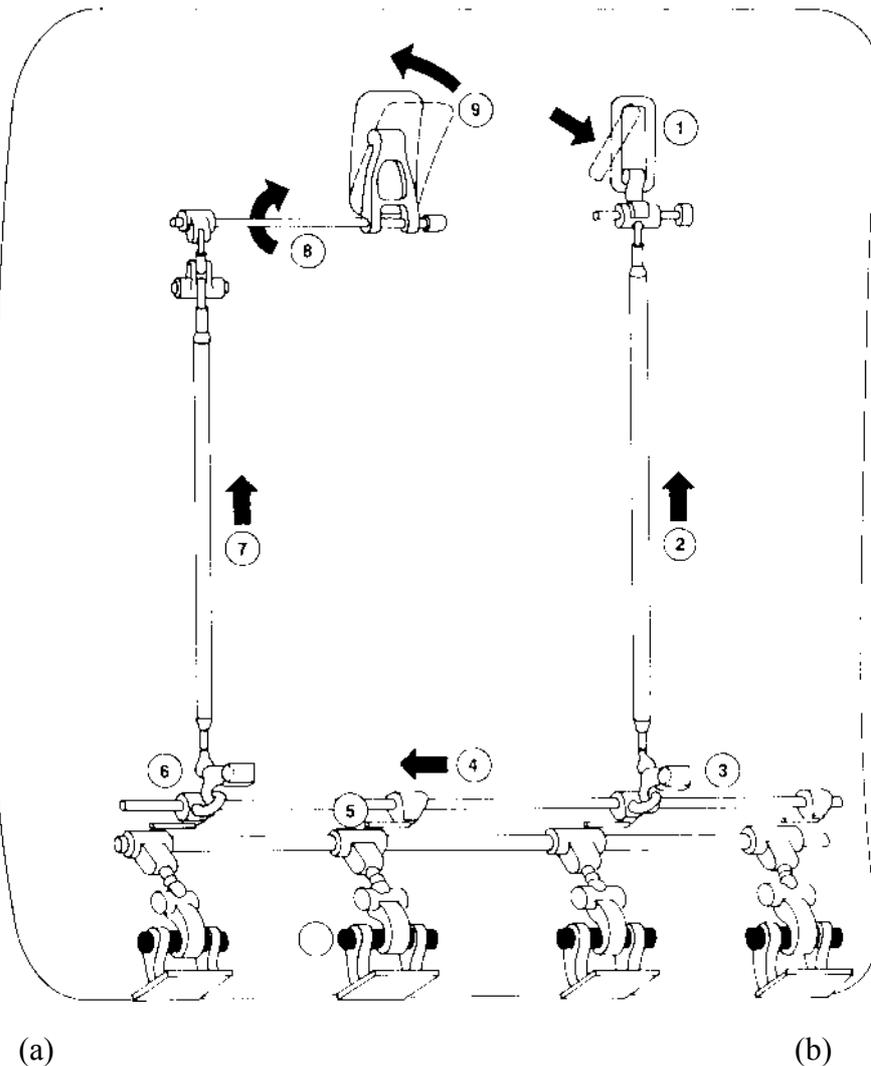
Figure 5: Different latch and vent door designs: (a) the 'coincidental' design utilized by McDonnell Douglas, and (b) the 'consequential' design used by competitors (Eddy et al., 1976).

The design of the DC-10's vent door was such that it did not properly indicate a successful locking of the cargo door. Figure 5 shows the design utilized by McDonnell Douglas as opposed to that employed by their competitors, Boeing and Lockheed Martin. The connection of the vent door to the handle as opposed to the other side of the locking pins makes its sealing a 'coincidental' rather than 'consequential' event. Indeed, it turned out to be

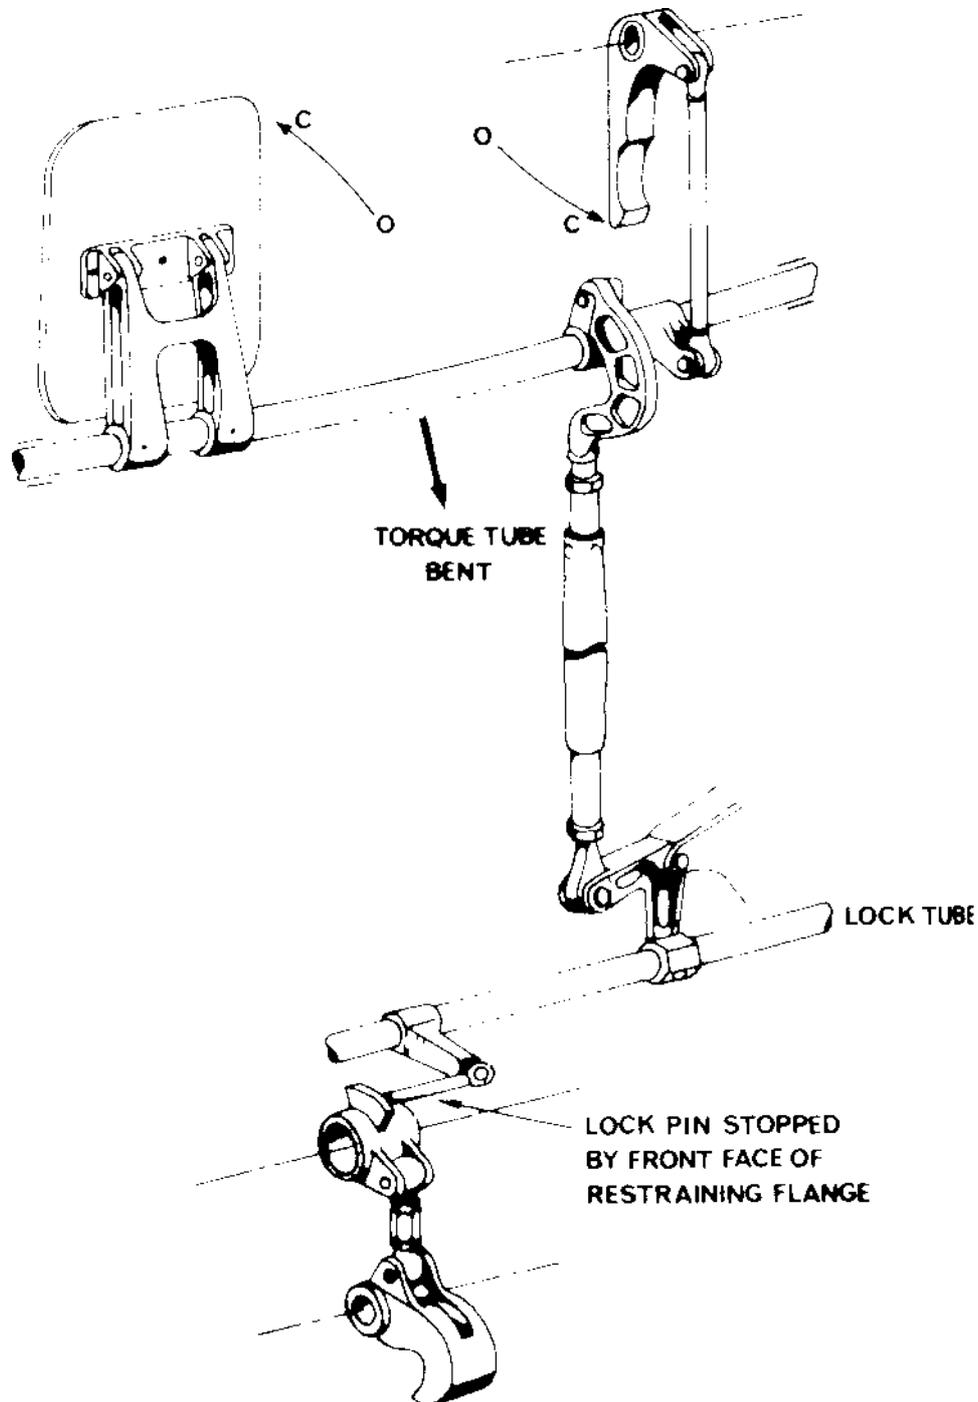
Figure 6: The torque bar failure (Eddy et al., 1976).

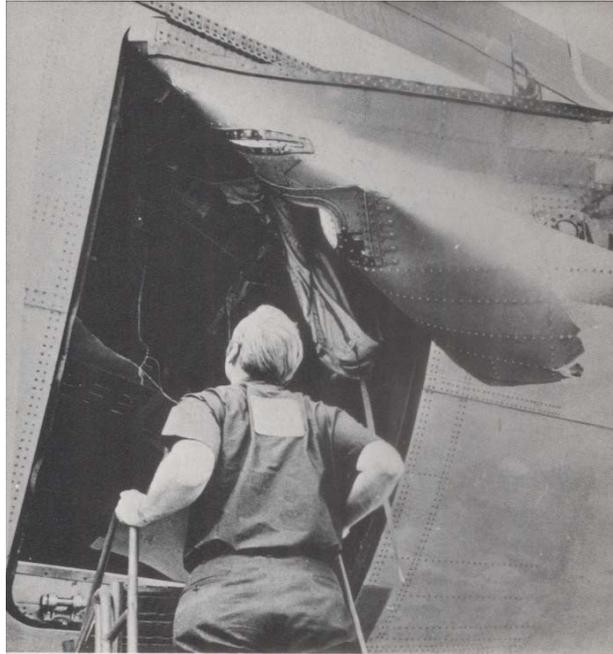
At an altitude of 11,750 feet, this rear cargo compartment door separated from the plane in flight. The rapid decompression that followed caused the floor to partially collapse into the cargo compartment, breaking various hydraulic control cables that were routed through the floor beams to the rear control system. The National Transportation and Safety Board (NTSB) report on the Windsor Incident notes that this cabin floor was not equipped with pressure relief vents that could prevent the floor from buckling (Fielder et al., 1992, pp. 94-97). Figure 7 displays the power of the explosive decompression experienced by the Windsor aircraft.

Figure 7: The remains of the cargo door after the Windsor Incident (Eddy et al., 1976).

The proposed modifications included the installation of a peephole through which a baggage handler could visually confirm proper position of the locking pins and a support plate for the torque tube attached to the handle which was susceptible to bending and would then falsely allow the vent door to close (see item 9 in Fig. 5-a) (Fielder, 1992, pp. 78). These fixes, while avoiding the primary problem of the collapsing floor and subsequent severing of the hydraulic lines, might have proved sufficient if they had been properly carried out. Due to the routine nature of the service bulletins, implementation of these modifications was relatively sluggish (Eddy et al., 1976, pp. 157). On the DC-10 that ultimately became Turkish Airlines Flight 981, it turned out that the support plate had never been installed, essentially dooming the aircraft to the same plight experienced over the previous years. A discrepancy in McDonnell Douglas's quality control system was later exposed when it was found that three inspectors falsely certified the modification with their stamp though none could remember it (French, 1982, p. 188). This event seems consistent with the inherent ground testing and certification conflicts of interest already discussed, a fault attributed largely to the FAA's lack of manpower. However, an alternative viewpoint is to shift primary responsibility for this to McDonnell Douglas, and in his essay, Peter French instead exposes and criticizes the regularity and listlessness of their corporate policies, stating that the "inspection procedure... invites or tempts inspectors to be lax and careless" (1982, p. 188).
